This is a condensed version of Lintech's Component Authenticity Inspection Report made from excerpts. Complete CAIRs contain approximately 20 pages.

Certificate of Compliance

Sample Report P/N: STK14C88-3N35I

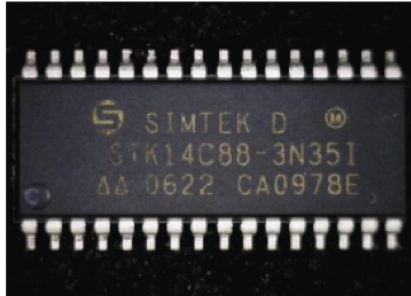
Figure 1
Typical Top View of Devices

1. A gross visual of the devices did not cause concern about the components indicating the devices are not authentic.
2. An external visual 40x of the devices did not present signs that would indicate the components are not authentic.
3. An X-Ray of the devices did not present any obvious defects that would indicate the components are not authentic. All devices appear to have uniform die shape, die size, die bonding, and lead frame geometry. Exposure: 45.1 kV 1 minutes 25 seconds
4. An XRF of the devices did not present any obvious incorrect composition that would indicate the components are not authentic.
5. Physical dimensions measurements of the device did not present any obvious defects that would indicate the components are not authentic.

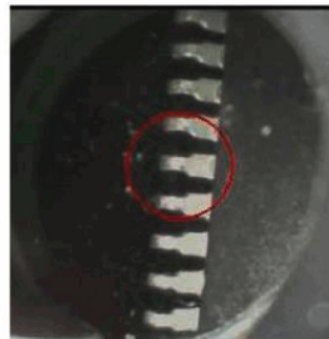
Typical Test Summary

Reading No	2108
Mode	Electronics Metals
Time	2015-08-11 10:17
Duration	30.00
Units	ppm
Sigma Value	2
Sequence	Final
PART NUMBER	STK14C88-3N35I
DATE CODE	0622

ppm	±	Error
Sn	684547.375	±	18523.031
Cd	0	:	N/A
Pb	143795.078	±	5379.172
Hg	0	:	N/A
Cu	162816.969	±	6430.678
Ni	0	:	N/A
Cr	0	:	N/A
Al	0	:	N/A
Ag	0	:	N/A
Au	0	:	N/A

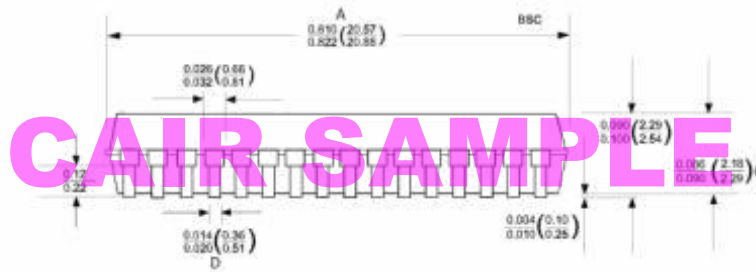
Package Diagrams

32-pin 300 mil SOIC Gull Wing

DIM = INCHES MIN MAX
 DIM = mm (MIN MAX)

Dimensions	A	B	C	D
Minimum	0.810	0.405	0.086	0.014
Typical	-	-	-	-
Maximum	0.822	0.419	0.090	0.032
Sample Number	XXXXXXXXXX			
A	0.8205	0.4125	0.0885	0.0160

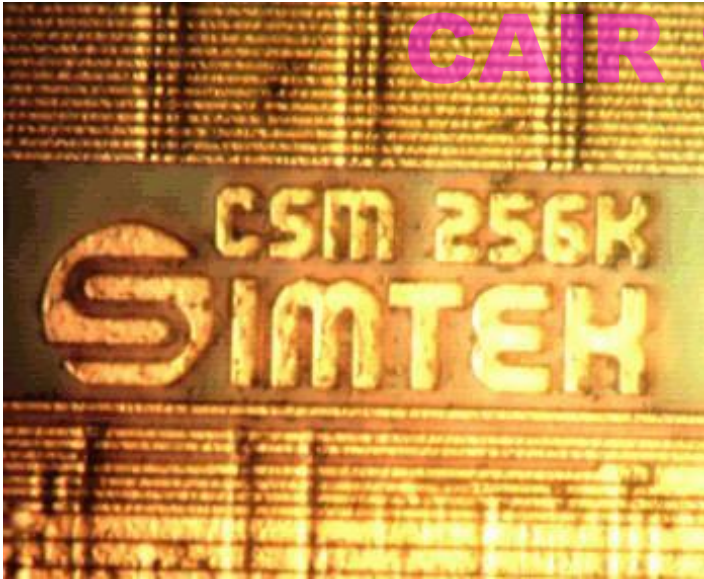
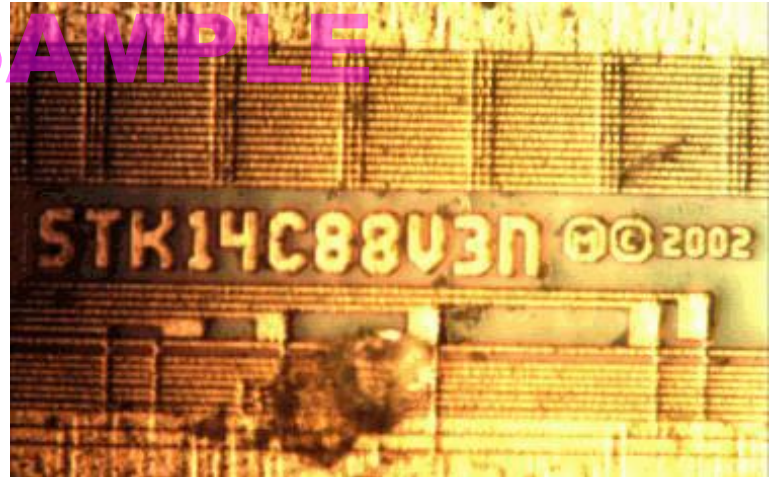
Die Marking

Notes:
 6. Die Marking: CSM 256K - SIMTEK - STK14C88V3N M C 2002
 7. No die map on file.
